COMMON CAUSE FAILURES

1 Theory versus Practice

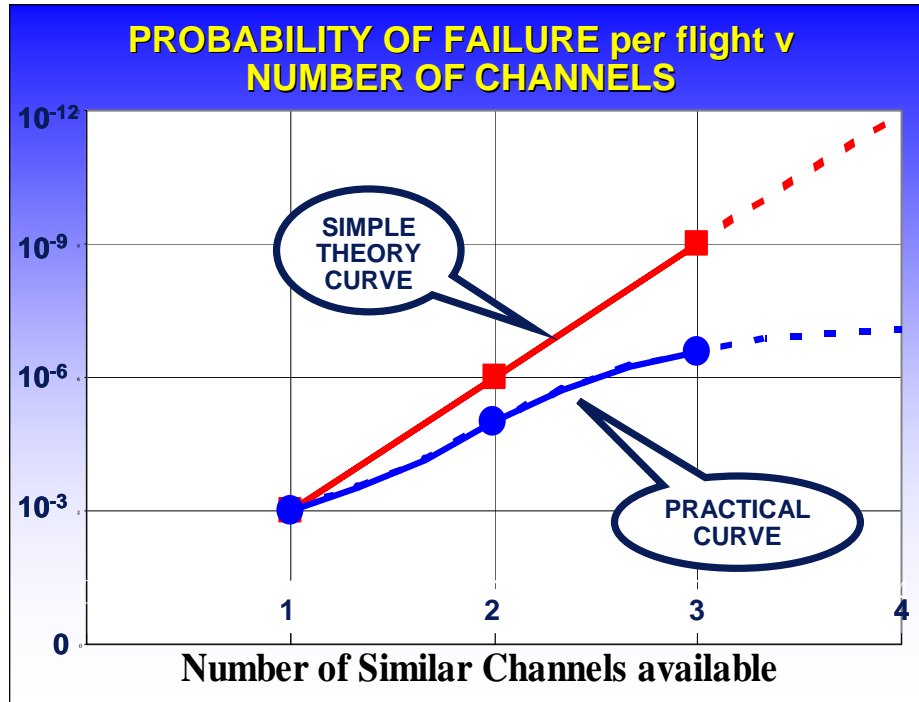
However, when the in-service record for the subject aircraft was investigated it was found that multi-channel failures occurred at a much greater frequency than predicted by the simple theory. Figure 1 shows both the simple theoretical, and the practical, relationship between the probability of total systems failure and the number of systems or channels available.

Figure 1 Probability of Failure against number of channels for an aircraft electrical power generation system

It can be seen from Figure 1 that for the three-channel system the frequency of total system failure is several hundred times greater than the simple theory suggests. Significant differences also exist, between practical experience and the simple theory prediction, for aircraft hydraulic systems as illustrated in Figure 2.

However, the primary reason for the differences between the simple theoretical curve and the practical curve shown in Figure 1 and Figure 2, is that channel failures are not totally independent and that Common Cause failures have a significant influence on the probability of total system failure actually achieved.

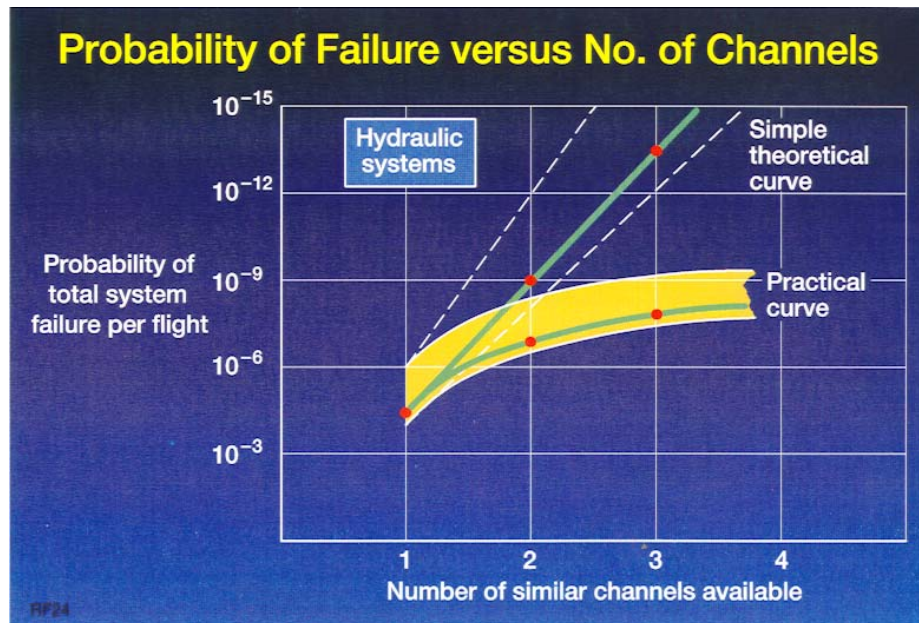
Figure 2 Probability of Failure against number of channels for an aircraft hydraulic power generation system

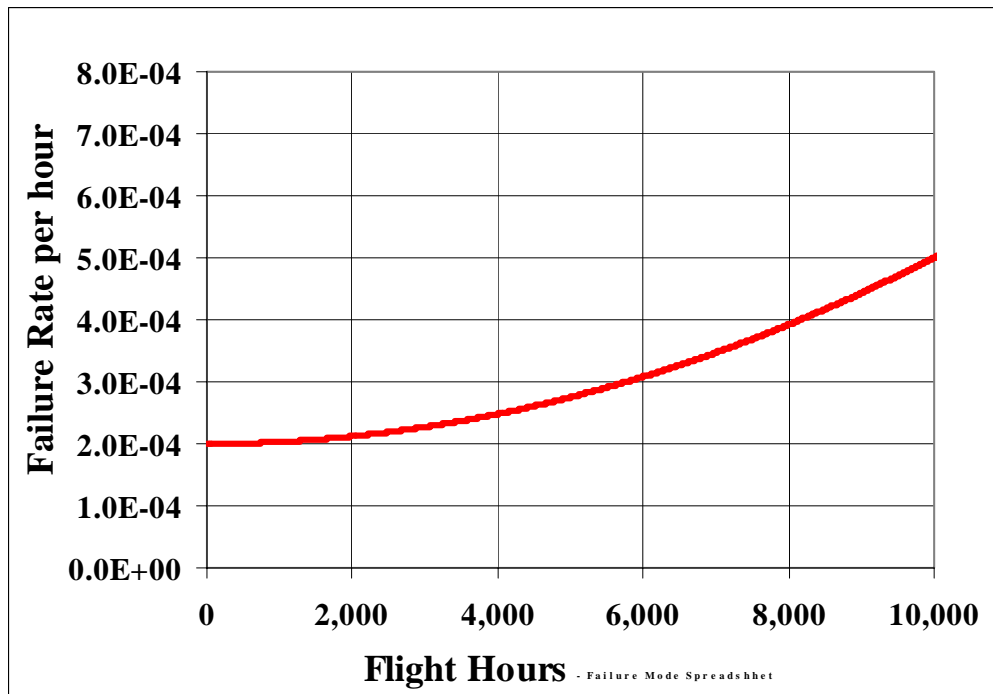
Consider a component in a two-channel system exhibiting the failure rate characteristics shown in Figure 3.

Figure 3 Multi-channel system component exhibiting “wear-out” characteristics

When the aircraft first enters service, the component has a failure rate that is approximately 2×10^{-4} per hour. However, if the component survives in both channels for 10,000 flight hours each of the similar components will have a failure rate of approximately 5×10^{-4} per hour. For an aircraft that has an average flight time of one hour the probability of both channels failing due to this component, when the aircraft first enters service, is approximately $(2 \times 10^{-4})^2$ - equal to 4×10^{-8} per hour. However after the aircraft has been in service for 10,000 hours the probability of both channels failing due to this component is approximately $= (5 \times 10^{-4})^2$ equal to 25×10^{-8} per hour. Hence, the probability of both channels failing due to this component has increased by a factor of **6.25**. A similar situation exists if the component exhibits an infant mortality failure rate characteristic, perhaps resulting from manufacturing or maintenance induced defects.

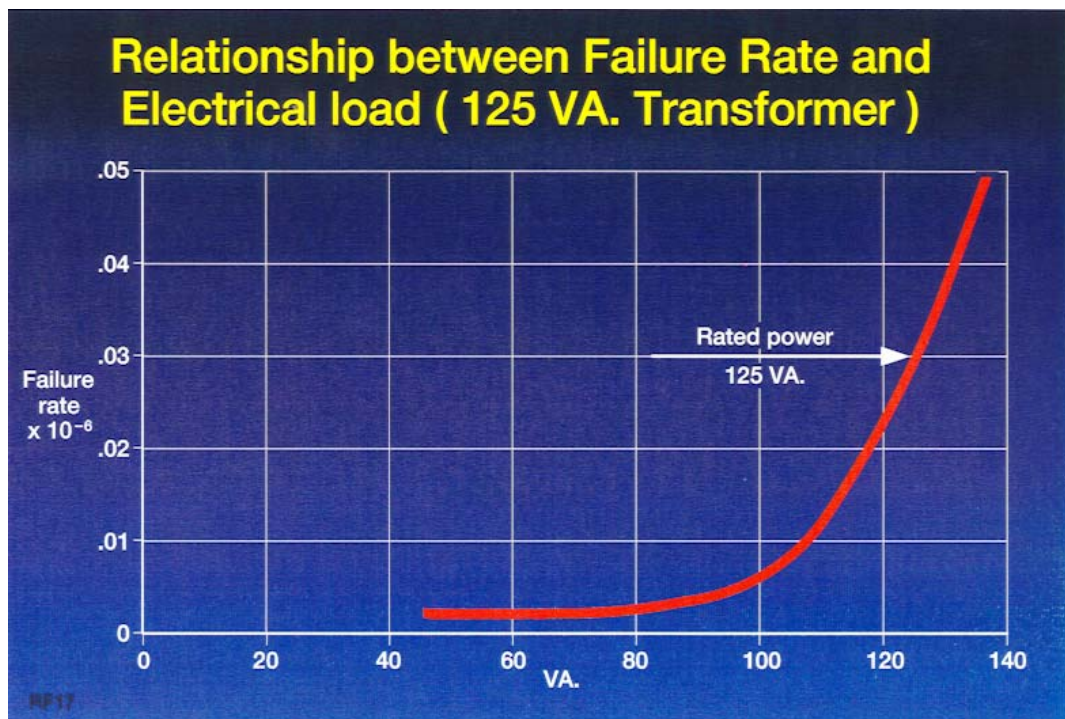
Attempts have been made to quantify the relationship between load and failure rate for electrical components - the results of this work are contained in MIL-HDBK-217 "Reliability Prediction of Electronic Equipment." Figure 4 shows the relationship between failure rate and load for a 125 VA transformer using the data from MIL-HDBK-217. It may be seen that for this particular component there is a marked difference between the predicted failure rate at rated power, 125 VA, and half-rated power. Most components will demonstrate an adverse relationship between failure rate and load, although not necessarily as severe as the example shown in Figure 4.

Figure 4 Relationship between Failure rate and Electrical Load for a 125 VA Transformer

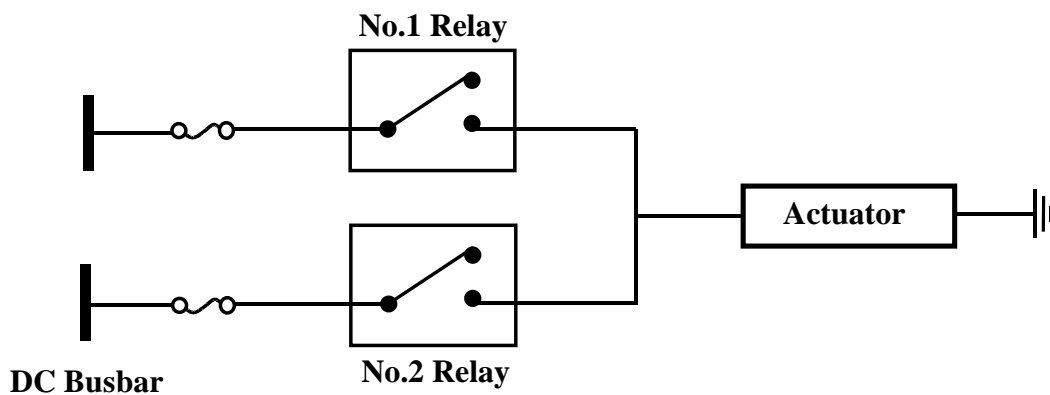
Considering the system shown below, the circuit has been duplicated upstream of the actuator terminal block in order to improve the reliability of operation. However, any single short circuit in the system will result in loss of the entire system and, since there are two micro-switches, the probability of this occurrence is significantly greater than that of a single channel system.

Of course, in practice, the effects of short circuits would be limited by the addition of diodes, but this does have the disadvantage of increasing the potential for failure in the system.

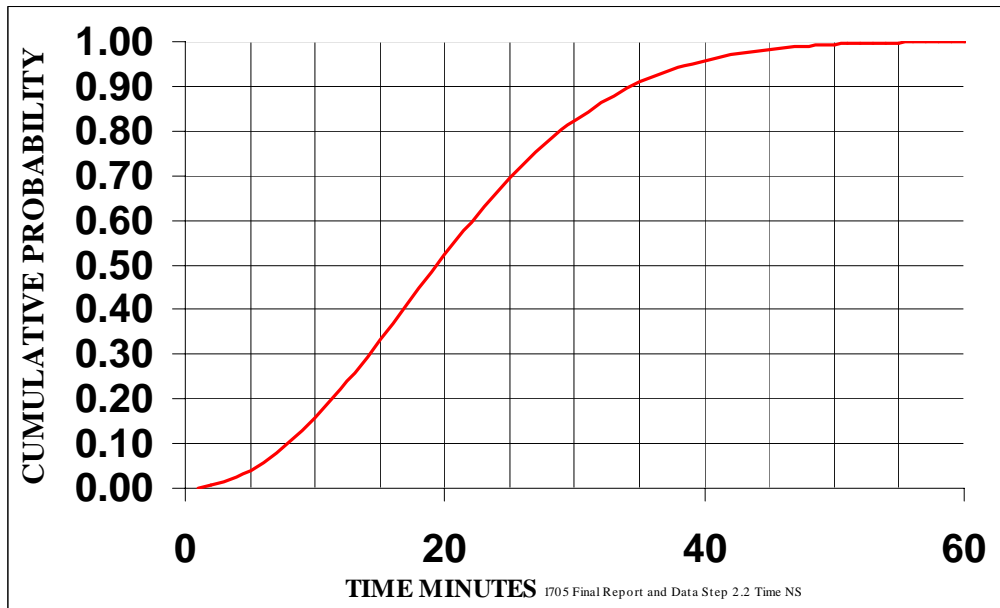
It is often not appreciated how rapidly an in-flight fire can progress. Based on a study of past accidents carried out for the FAA the assessed distribution of the time for a potentially catastrophic fire becoming non-survivable is as shown in Figure 6.

Figure 6 Cumulative Probability Distribution of Time to Become Non-survivable following an in-flight fire occurrence.
